## USAAVLABS TECHNICAL REPORT 69-97

*CB*  
*2*  
**INVESTIGATION TO DETERMINE THE FEASIBILITY OF  
DETECTING IMPENDING METAL FATIGUE FAILURE  
THROUGH USE OF AN INDUCTIVE SENSING DEVICE**

**U. S. ARMY AVIATION MATERIEL LABORATORIES  
FORT EUSTIS, VIRGINIA**

**MECHANICAL TECHNOLOGY INCORPORATED  
LATHAM, NEW YORK**

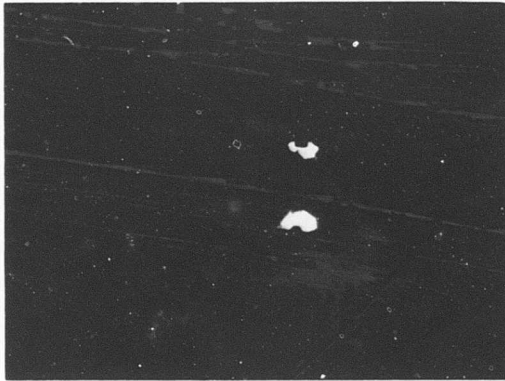
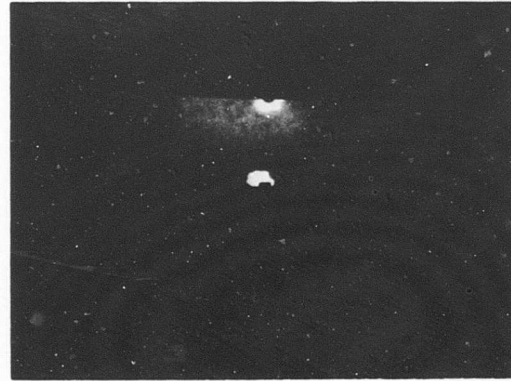
(a)

Figure 6. Comparison of Inductive Sensor With Dye Penetrant Technique.

an inductive scan, and Figures 6a and 6b show heavily filtered photographs of the Zyglo test. Figure 6b shows no indication of dye penetration, while Figure 6a shows two dots (plus one dust particle) in the area where the crack would be expected.

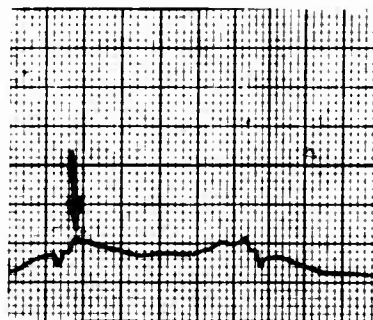
(b) 1 cycle

Figure 8. Preliminary Examination of Steel Sample.

Figure 8b shows the effect of one cycle upon the probe signal. One cycle consists of bending the two ends of the sample (see Figure 7) up to a total angle of 10 degrees and subsequently bending the ends back down to maintain flatness of the top surface. Figure 8 shows a definite growth of the signal over the notch.

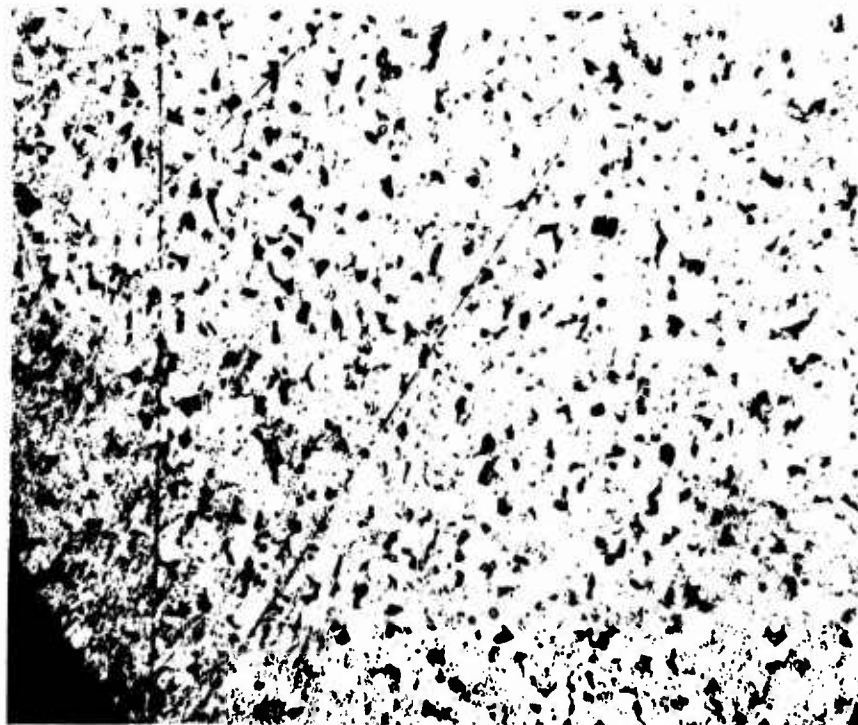
(j) X100 Mag, Etched, Notched Area

At this point, the surface was lightly polished and the sample was subjected to one more cycle. Figure 10h shows the area above the notch, and Figure 10i shows the area away from the notch. The mottling of the surface above the notch indicates that the material had been worked. Figures 10 j through 10m show the notched area and unnotched area at 100-power and 300-power magnification after a 2% Nital etch. The two areas show essentially the same structure with a slightly preferential attack by the etchant on the worked surface.

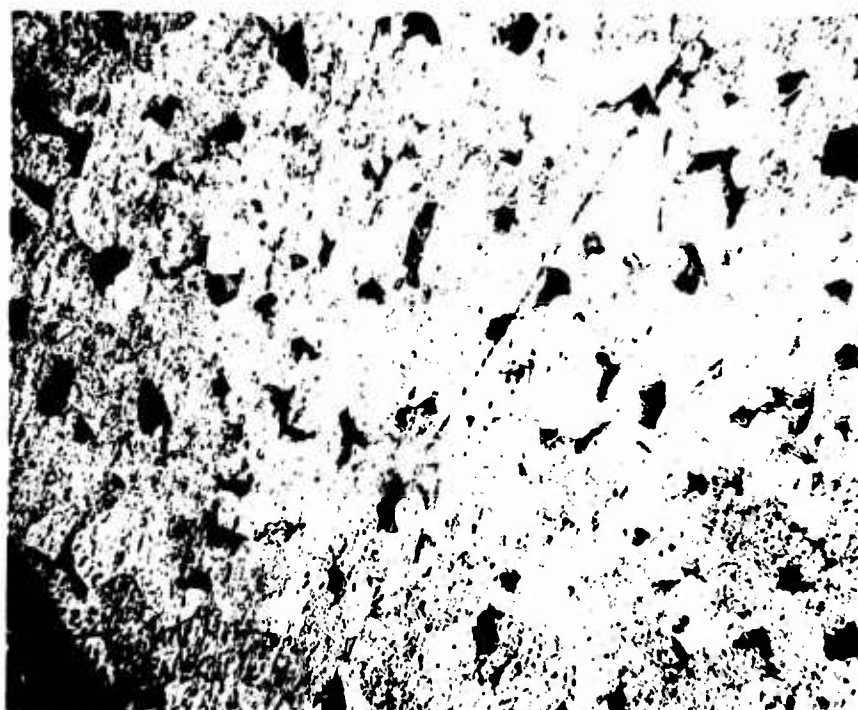
(k) X300 Mag, Etched, Notched Area

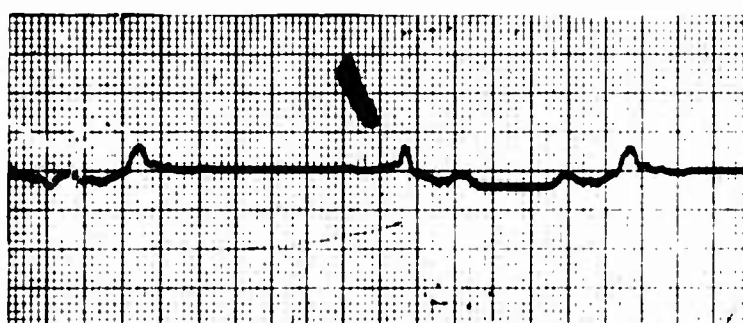
(n) Inductive Scan, 1 Additional Cycle

Figure 10n shows the inductive scan of the surface after the polishing operation and after the one additional cycle, but prior to etching. The signal is unmistakable.

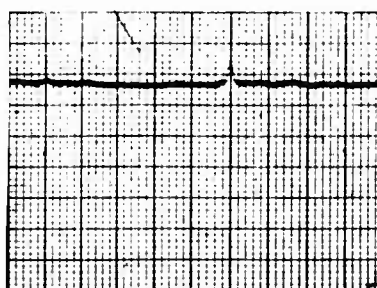
(m) 596,000

Figure 23. (continued)

The tapes from two sample runs are presented in Figures 23 and 24. Figure 23 shows tapes from the roll test for sample 10. The baseline remained quite smooth and regular through 12 readings to 585,000 cycles. At 596,000 cycles, a change occurred in the character of the noise from the machine; the scan was taken. Visual examination disclosed a small pit, which has been defined as evidence of failure.

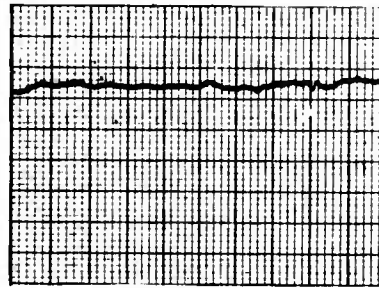
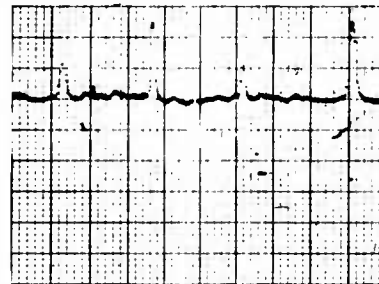
Figure 24. (continued)

Figure 24 shows the tapes from sample 9. Again, the baseline was smooth until the reading at 532,000 cycles, at which point a small, repeated (due to the shaft rotation) signal appeared. Approximately 3,000 cycles later, a large pit developed in the sample. A photograph of a sample showing a typical large pit of the characteristic triangular shape is shown as Figure 25.

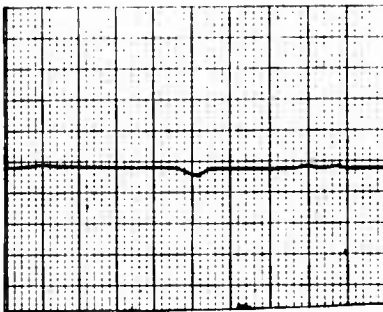
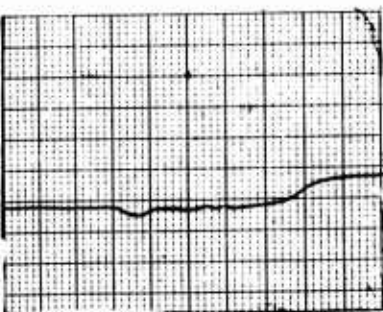
800,000 Bending Cycles

Figure 27. (continued)

The inductive sensor scans of aluminum sample 5 are presented as Figure 27. Readings were taken at pretest, at 400,000 cycles, and at 600,000 cycles; a signal appeared at 800,000 cycles on the back surface. The sample was then run further to 915,000 cycles to generate a sizable crack. It should be noted that at 800,000 cycles, the signal shows a depression with a small "pip" in the center. At 900,000 cycles, the signal shows two large depressions, one on each side of the central signal. It is significant that this type of signal has been observed throughout the program as being characteristic of an incipient failure on an aluminum sample. A question has been raised as to the phenomenon responsible for this characteristic signal on aluminum. This can be answered by a study of Figures 28, 29, and 30. Figure 28 clearly shows a crack that turns into an indentation on each side of an extrusion. Figure 29, taken closer to the center of the sample, shows an apparent tearing of material along the crack. The surface scratching, which is apparent but not serious in these scanning microscope pictures, is serious enough to obliterate detail in the electron microscope pictures. Figure 30 shows the leading end of the crack, 4.2 mm from the root of the notch. The photographs are labeled with a letter and one dimension. The letter indicates the distance from the root toward the center of the sample. Since the notch separation is 9.4 mm, Figure 30 is taken .5 mm from the center line of the specimen. From previous experiments, it has been determined that the area of sensitivity of the probe encompasses a width of approximately 4 mm (2. mm each side of center). Therefore, cracks shown in the photographs will be responsible for a signal indication if the dimension shown is greater than 2.7 mm. Figures 32, 33, 34, 35, and 36 are photomicrographs of sample 11 aluminum. The scan signals are shown as Figure 31. The last reading, 625,000 cycles (back), shows an extremely small "pip", which, experience has shown us, is the first indication of a valid flow signal. Figure 34 shows well-defined crack propagation; however, the position dimension shows that this was taken only 1.4 mm from the notch. Figure 35, taken .5 mm toward the center, shows much less damage, and the surface damage is seen to end at 2.1 mm in Figure 36. It is apparent that there is little damage beyond 2.1 mm, and the extremely small signal (most likely due to flux fringing at the edge of the probe, increasing the sensitive area) bears this out.

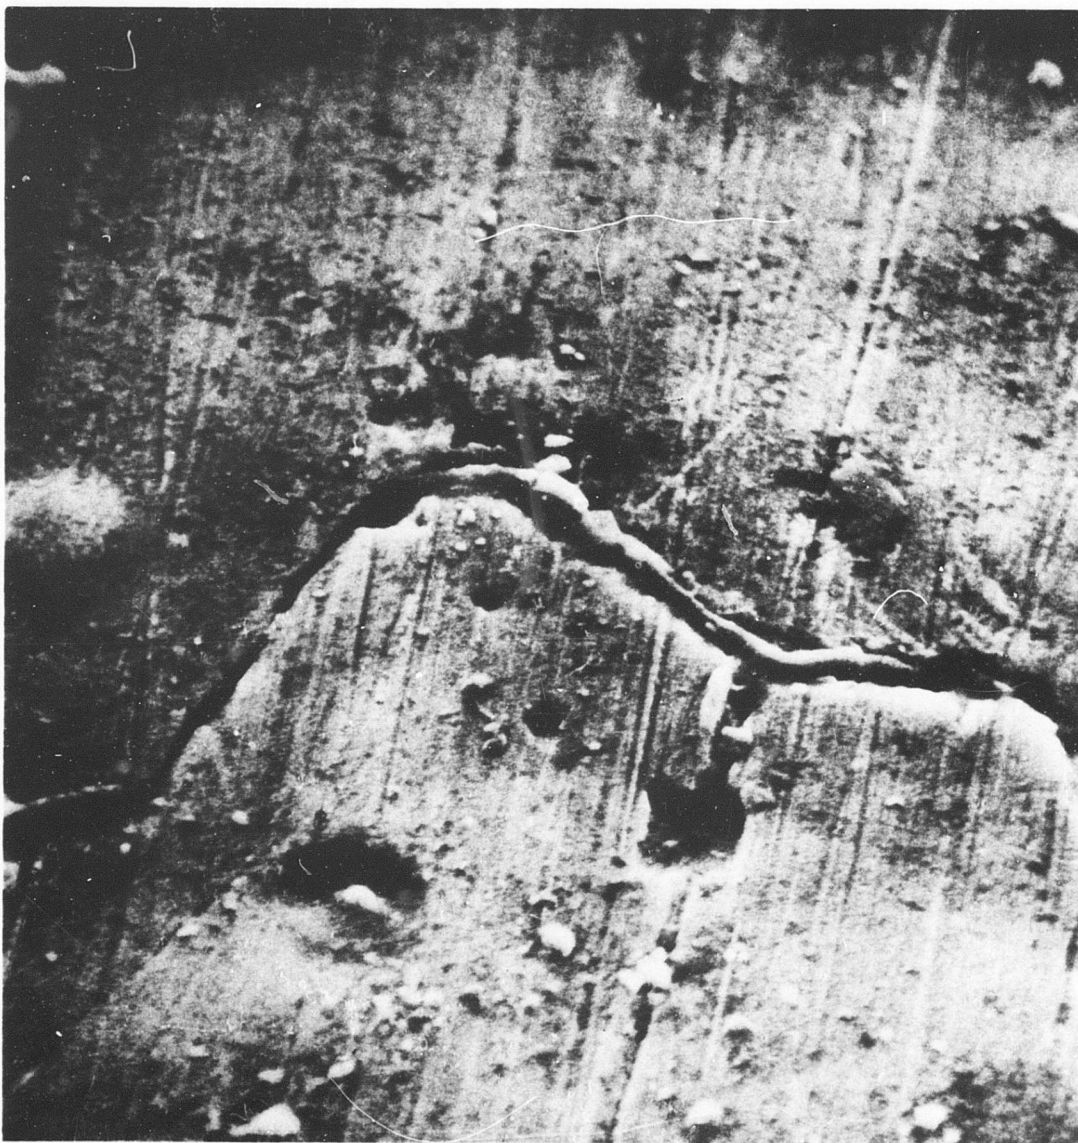
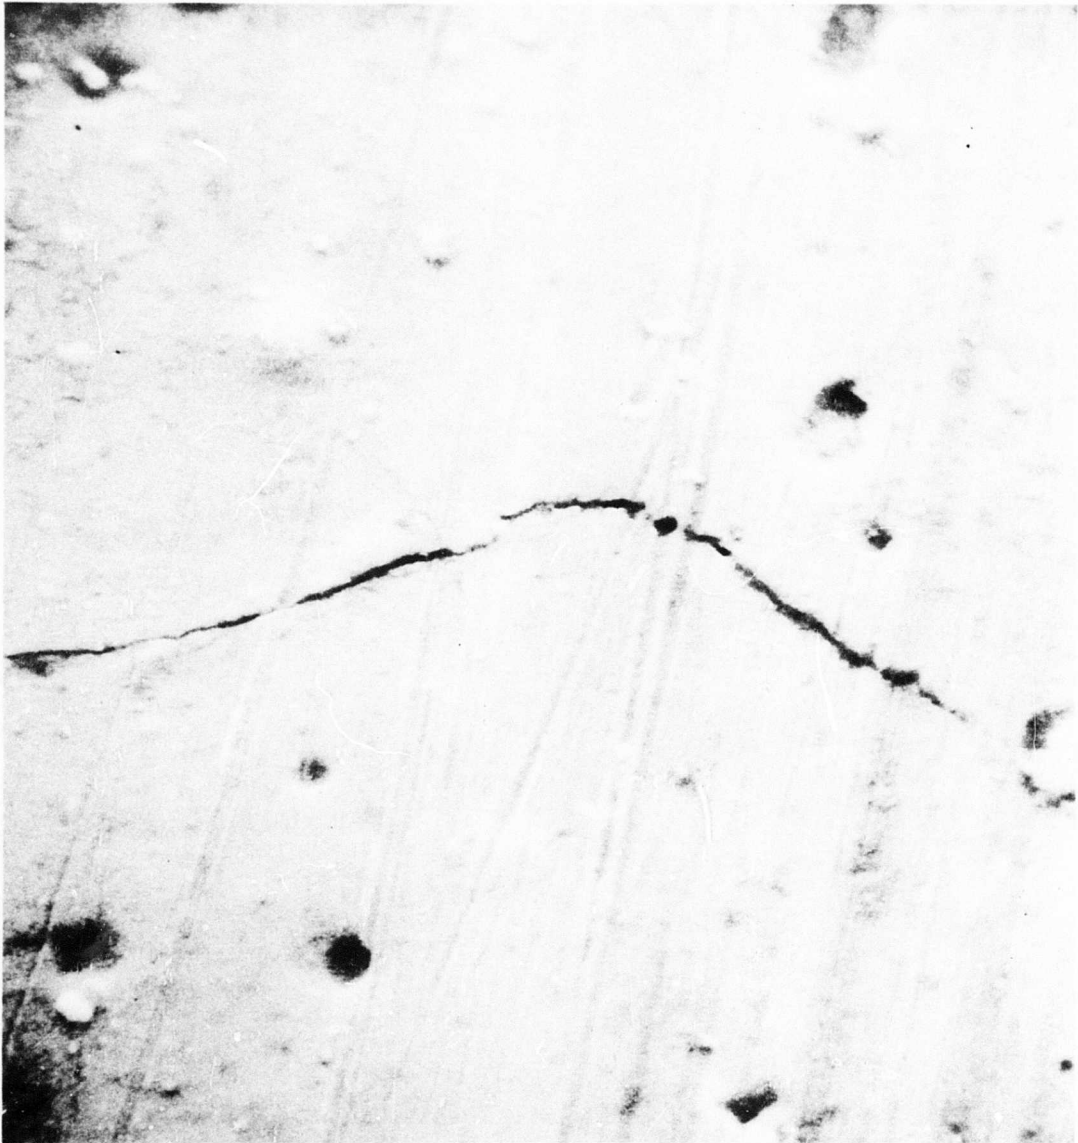
Figure 28. Aluminum Sample A5, X4000,  $d = 2.9$  mm.

Figure 29. Aluminum Sample A5, X2200,  $d = 3.2$  mm.

Figure 30. Aluminum Sample A5, X4000,  $d = 4.2$  mm.

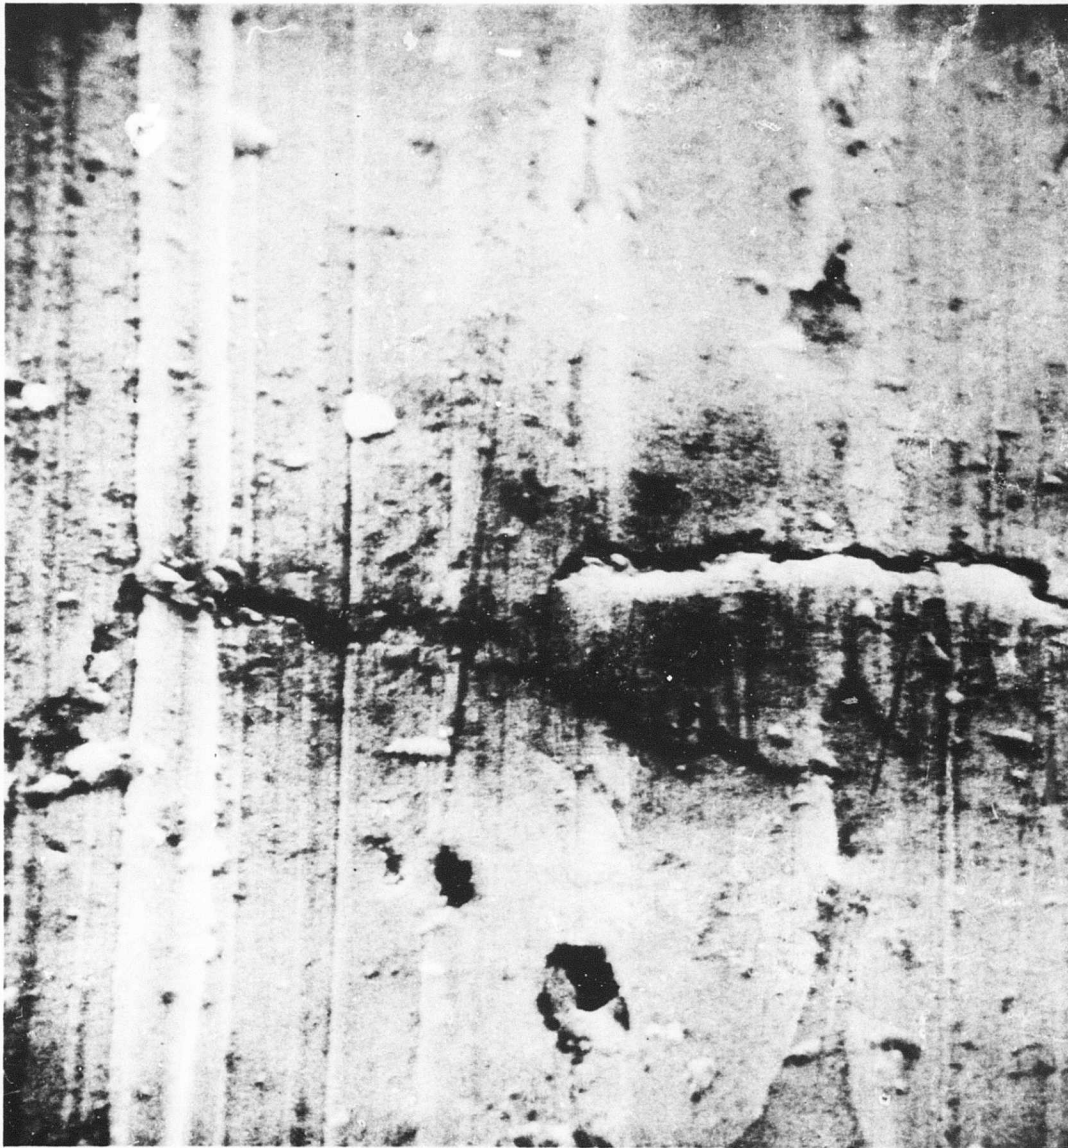
Figure 32. Aluminum Sample A11, X2200,  $d = 1.1$  mm.

Figure 34. Aluminum Sample A11, X4000,  $d = 1.4$  mm.

Figure 35. Aluminum Sample A11, X4000,  $d = 1.9$  mm.

Figure 36. Aluminum Sample A11, X4000,  $d = 2.1$  mm.

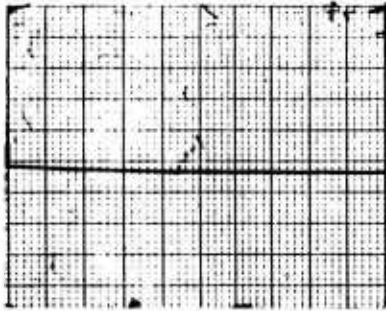
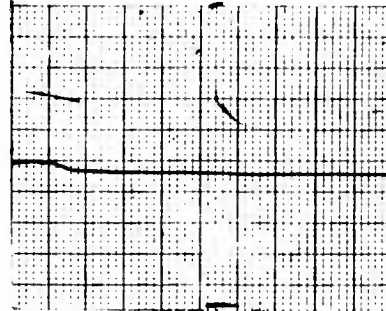
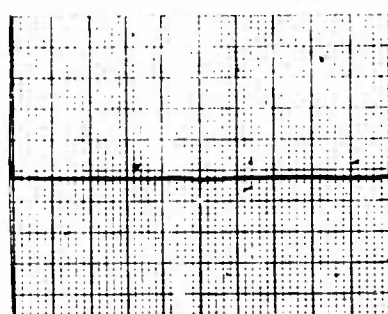
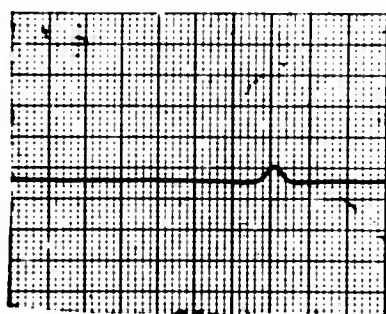
Figure 42. Inconel X Sample I10,  $\pm .070$ " Deflection.

notch and, in addition, very clearly show the presence of slip parallel to the crack. Figure 41 shows the furthest easily observable propagation of the crack. Again, the presence of slip is evident parallel to the crack. Figure 42 shows the inductive scans of Inconel sample I10. A sizable signal at 800,000 cycles motivated termination of the test and preparation for scanning electron microscopy. Figures 43, 44, 45, and 46 are photomicrographs of the sample taken at 1.74 mm, 2.05 mm, 2.46 mm, and 3.03 mm, respectively, from the root of the notch. As before, these figures show a decrease in crack size with distance from the notch. The pock marks visible in these figures are most likely caused by the electropolishing procedure used in the initial preparation of the sample.

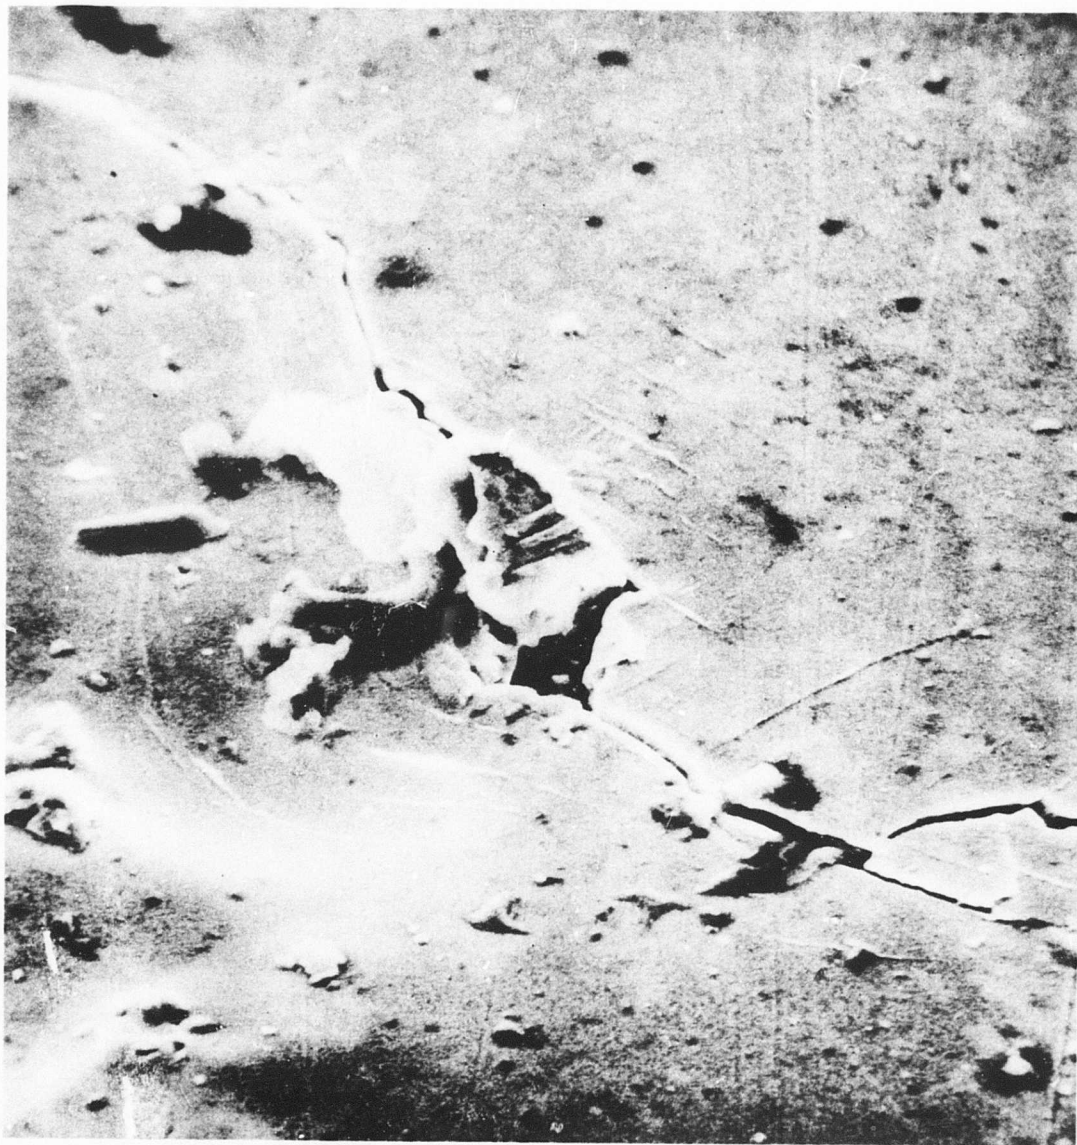
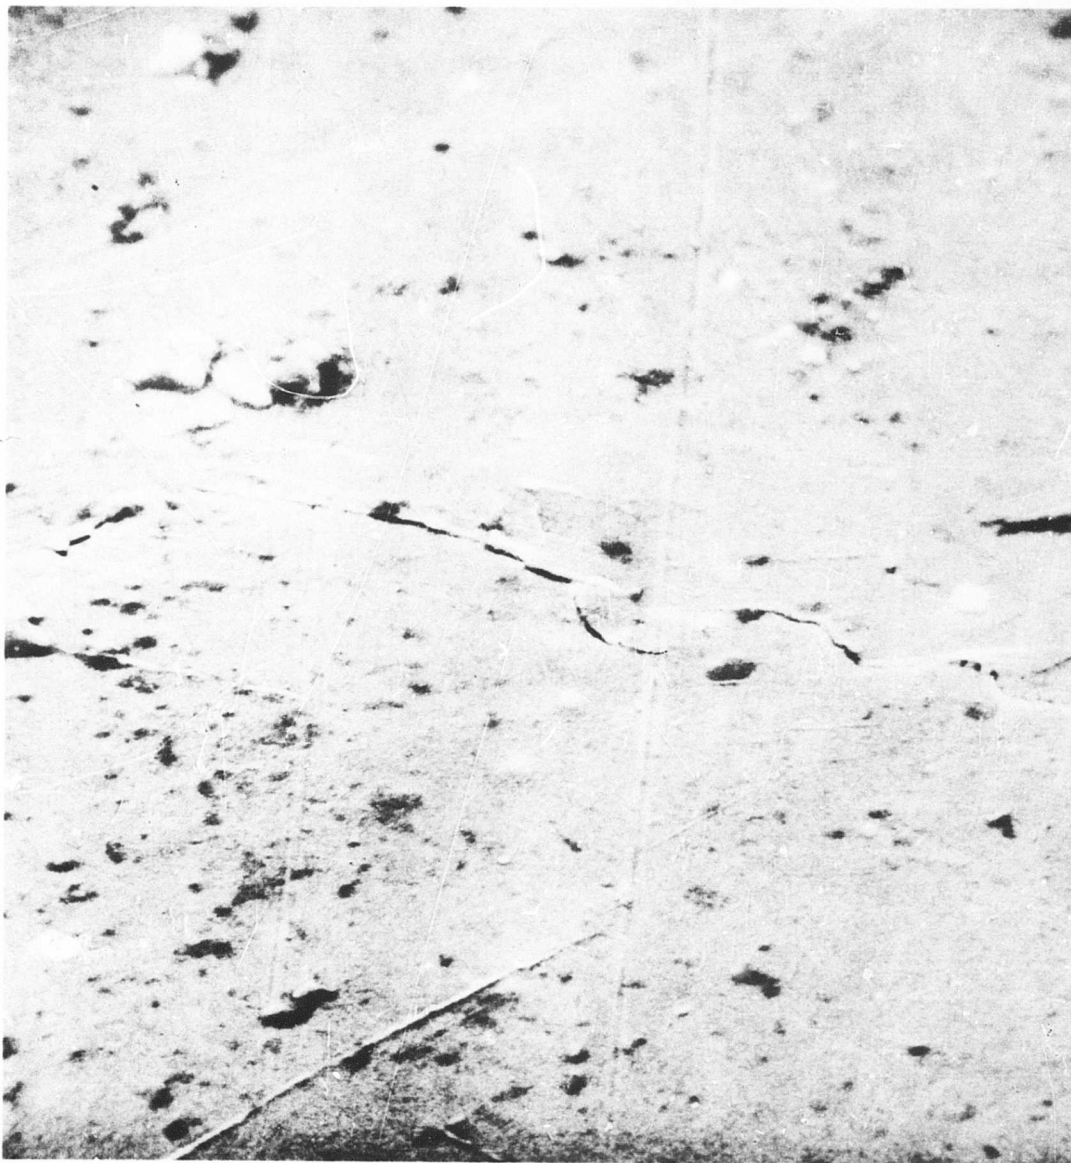
Figure 38. Inconel Sample I7, X4000,  $d = .73$ .

Figure 39. Inconel Sample I7, X2000,  $d = 1.50$ .

Figure 40. Inconel Sample I7, X4000,  $d = 2.28$ .

Figure 41. Inconel Sample I7, X4000,  $d = 2.41$ .

The inductive sensor scans of Inconel sample 117 are shown in Figure 37. As before, an extremely small signal at 1,100,000 cycles motivated termination of the test and preparation of the sample for scanning electron microscopy. Figure 38, 39, 40, and 41 show the damage at this point. Figure 38 shows gross damage at .73 mm from the root of the notch. Figures 39 and 40 show the crack at 1.5 and 2.28 mm from the

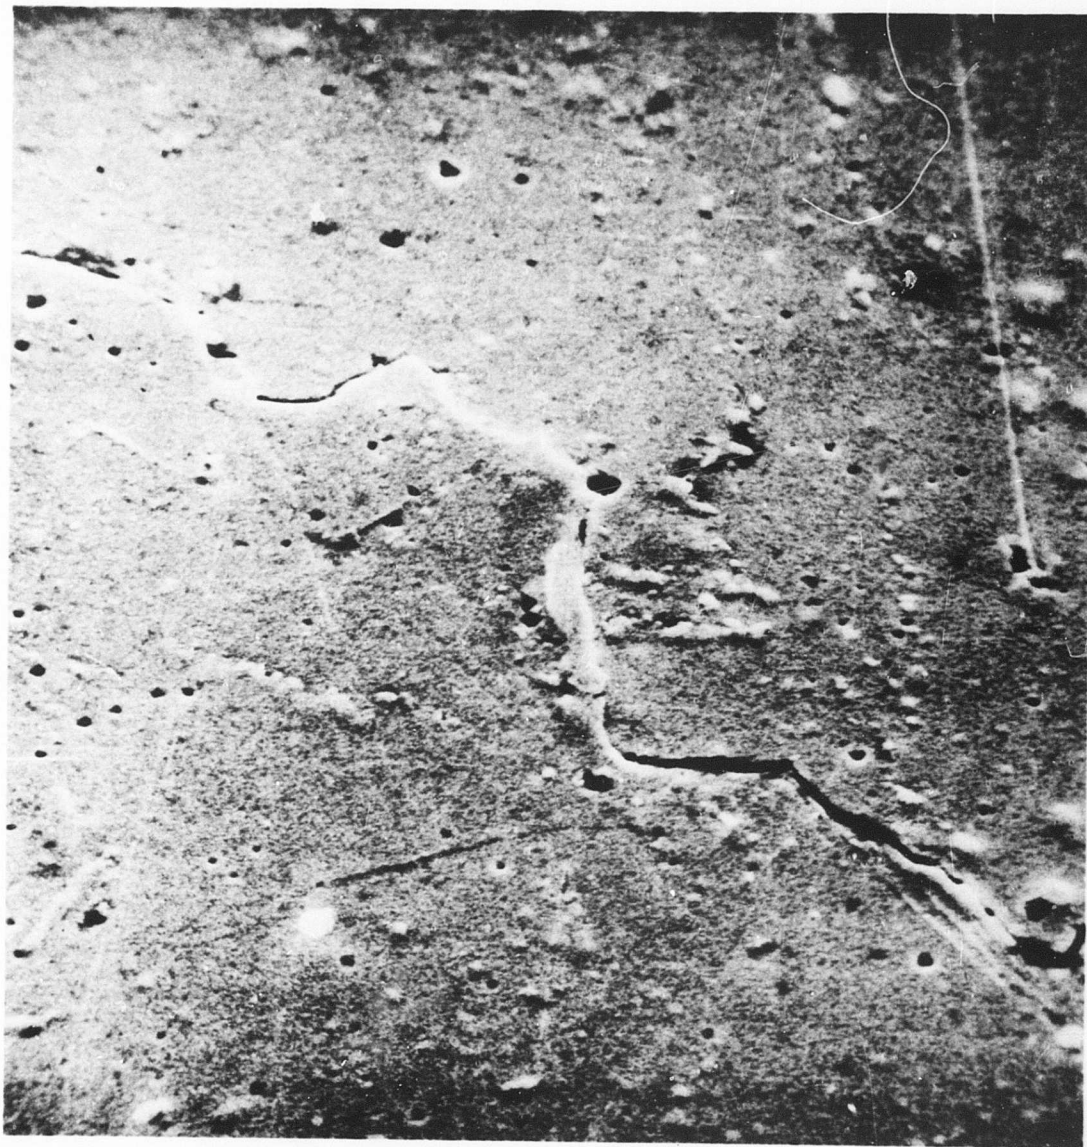
Figure 43. Inconel Sample I10, X4000,  $d = 1.74$ .

Figure 44. Inconel Sample I10, X4000,  $d = 2.05$ .

Figure 45. Inconel Sample I10, X4000,  $d = 2.46$ .

Figure 46. Inconel Sample I10, X4000,  $d = 3.03$ .

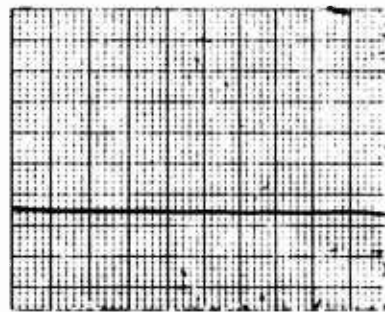
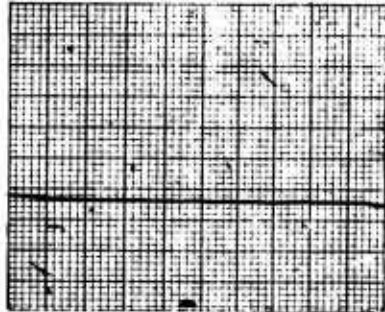
Figure 47. Steel Sample S11,  $\pm .055''$  Deflection.

Figure 47 shows the inductive scans on steel sample S11. A sizable signal is apparent at 350,000 cycles. At this point the sample was prepared, and the photomicrographs shown in Figures 48, 49, 50, and 51 were taken. In general, the slip seen in the Inconel micrograph is not evident, and the crack appears to be partially obscured by a white-appearing substance. This substance has been shown by electron microprobe analysis to be an oxide. As with the aluminum and Inconel samples, the photographs show a crack that decreases in size with distance from the root of the notch. It is significant to note that the crack has progressed further in the steel than in the other materials, which corroborates the later appearance of the signal in general for steel samples.

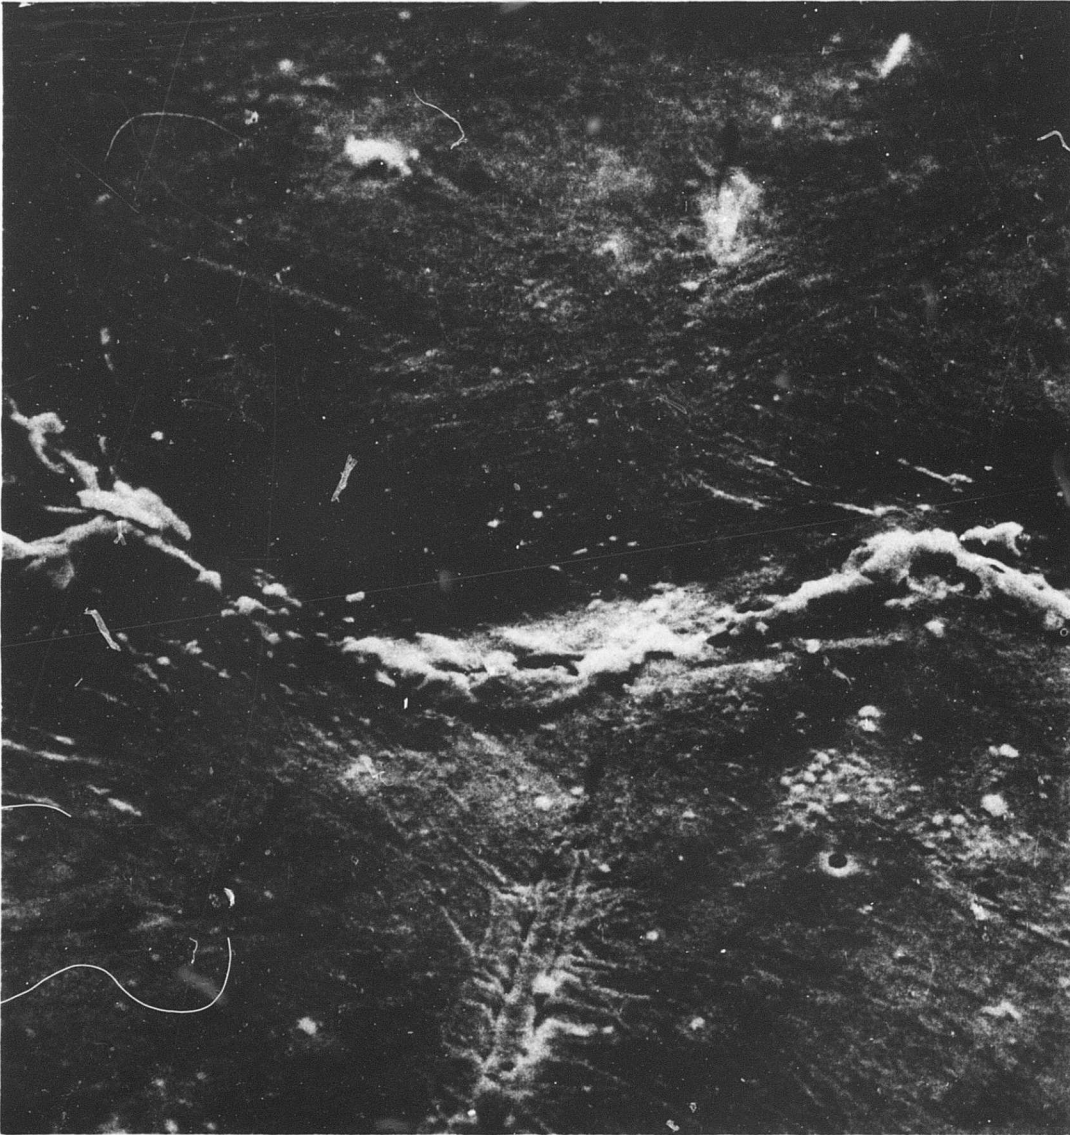
Figure 48. Steel Sample S11, X4000,  $d = 1.98$ .

Figure 50. Steel Sample S11, X4000,  $d = 4.16$ .

Figure 51. Steel Sample S11, X4000,  $d = 4.95$ .

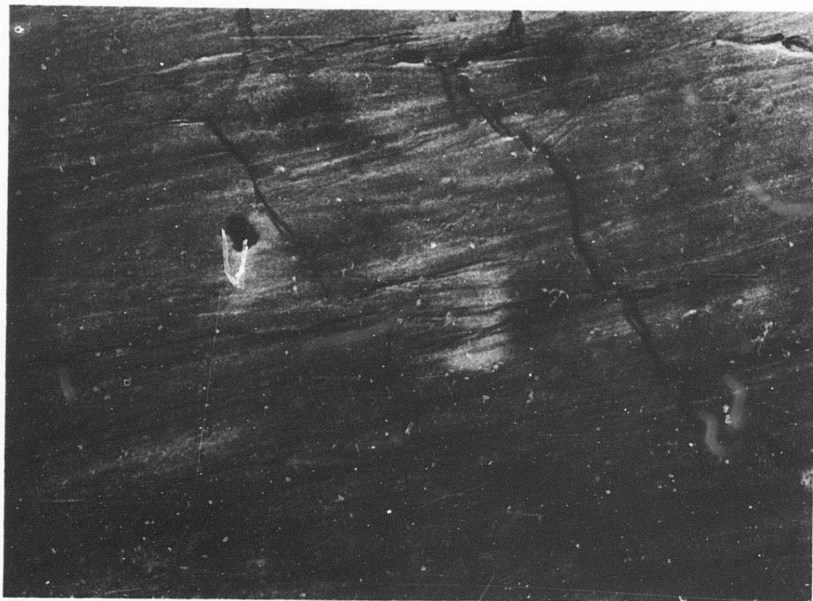
Figure 53. Surface of Sample A12, Slip in Vicinity of Crack, X9000.

presence of slip is seen. A better photograph of slip near a crack is shown in Figure 53, taken of aluminum sample A12 at 9,000-power magnification, where the slip is clearly normal to the scratches. Figure 54 shows the opposite surface of aluminum sample A12, also at 9,000-power magnification. No distinct cracks are seen (the white lines are most probably separations of the replica); however, the pits from the electropolishing are very clearly presented.

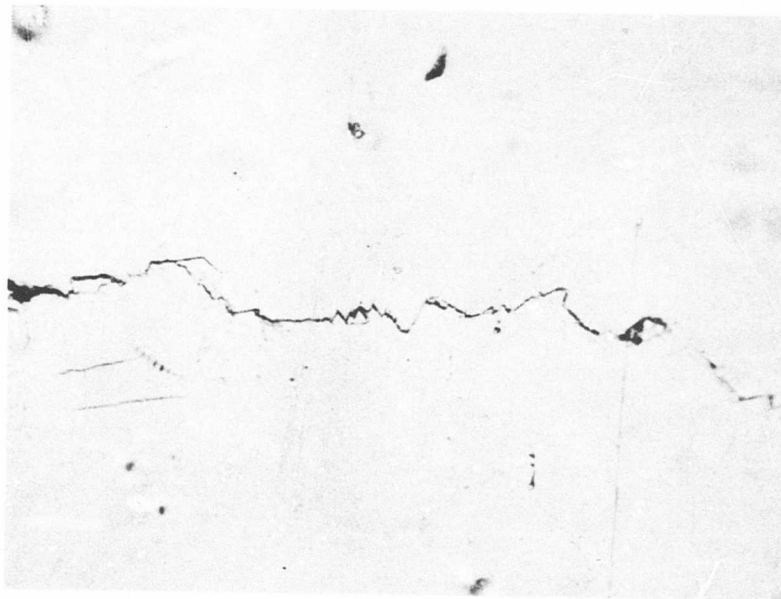
Figure 55. Overview of Crack on Surface of Inconel Sample I2, Clear Presence of Slip.

Figure 56. Sample I2, Crack Edge at Right, Slip Clearly Visible at Top Center, X3800.

Figure 57. Sample I2, Crack Edge at Right, Slip Clearly Visible at Top Center, X9000.

Figure 58. Sample I2, Primary Crack at Upper Left, Secondary Crack at Center, X9000.

Figure 59. Sample I2, Tip of Primary Crack, No Damage Beyond Tip, X9000.

Inconel has provided the most information from this examination, since the surface is quite free from scratches. Optical examination has shown slip to exist only near a crack; therefore, slip has provided a bench mark to corroborate proximity to a crack. Figure 55 shows an overview of the crack on Inconel sample I2 at 1,500,000 cycles. This photograph shows a jagged crack configuration and the presence of slip. Figure 56 shows the edge of the crack (right) and very clear slip bands at the center (Inconel sample I2, 1,100,000 cycles, 3,800-power magnification). Figure 57 shows an enlargement of the same area at 9,000-power magnification, where the slip bands are clearly visible. Figure 58 shows clear slip bands in the vicinity of a crack (upper left) with what appears to be a secondary crack (same replica and magnification). Figure 59 shows the tip of the primary crack (9,000-power magnification, Inconel sample I2, 1,100,000 cycles). It is important to note that there is no evidence of distressed metal in front of the crack, corroborating the conclusion of the examiner that no other features were seen.

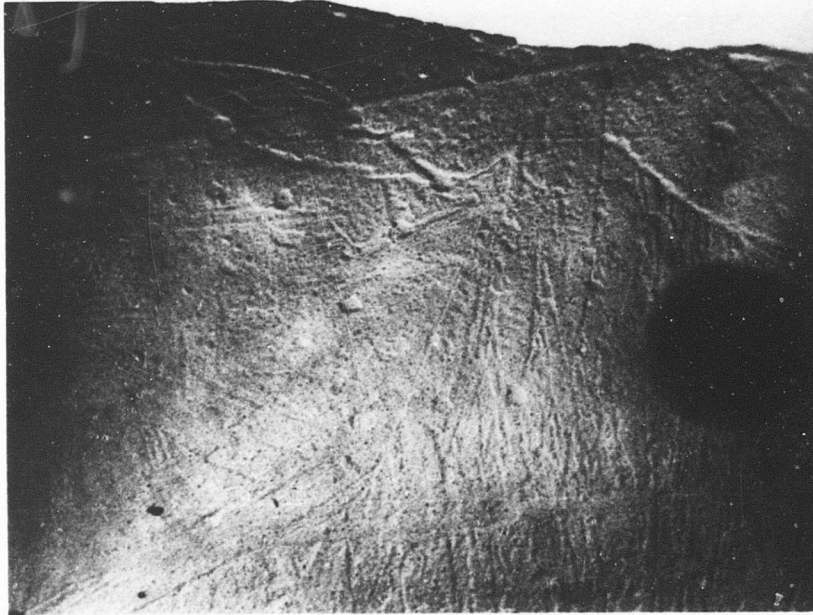
Figure 62. Sample S1, Edge of Crack at Top, No Slip Evident (Characteristic Observation for Steel Samples), X9000.

Figures 60 and 61 clearly show the martensite-like structure on the surface of the steel samples. Figure 60 shows steel sample S1 at 3,000-power magnification, and Figure 61 shows steel sample S2 at 3,000-power magnification. Figure 62 shows a crack edge of steel sample S1 at 9,000-power magnification. The martensite-like structure is clearly visible; however, little or no slip is seen near the crack (as it was for Inconel and aluminum) because of the fineness of the micro-structure.

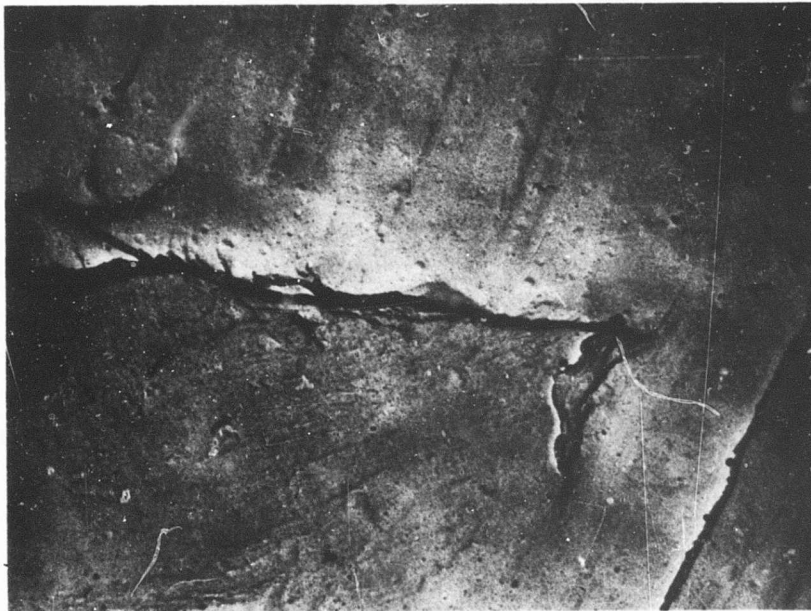
Figure 63. Sample S1, Tip of Primary Crack, No Evidence of Other Material Damage, X9000.

Figure 63 shows the tip of the main crack on steel sample S1, 750,000 cycles at 9,000-power magnification. Some structure is seen; however, features other than the crack, which could give rise to a signal, are not evident.

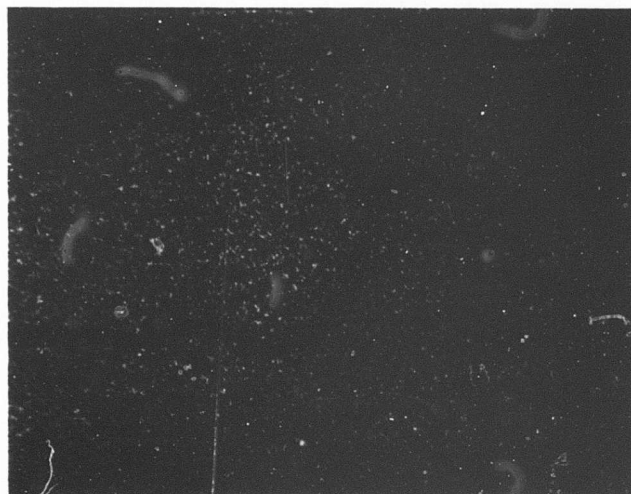
Figure 64. (continued)

(d) Specimen Current Image of Crack in Aluminum,  
Site D

(e) Crack in Aluminum, Site D, Al  $K_{\alpha}$  Line,  
200K Counts

(f) Crack in Aluminum, Site E, Al K <sub>$\alpha$</sub>  Line,  
400K Counts.
